STATIONWIDE
ENVIRONMENTAL BASELINE SURVEY AND
RELATED ENVIRONMENTAL FACTORS
ONTARIO AIR NATIONAL GUARD STATION
CALIFORNIA
November 1996

STATIONWIDE ENVIRONMENTAL BASELINE SURVEY
ONTARIO AIR NATIONAL GUARD STATION, CALIFORNIA

NOVEMBER 26, 1996

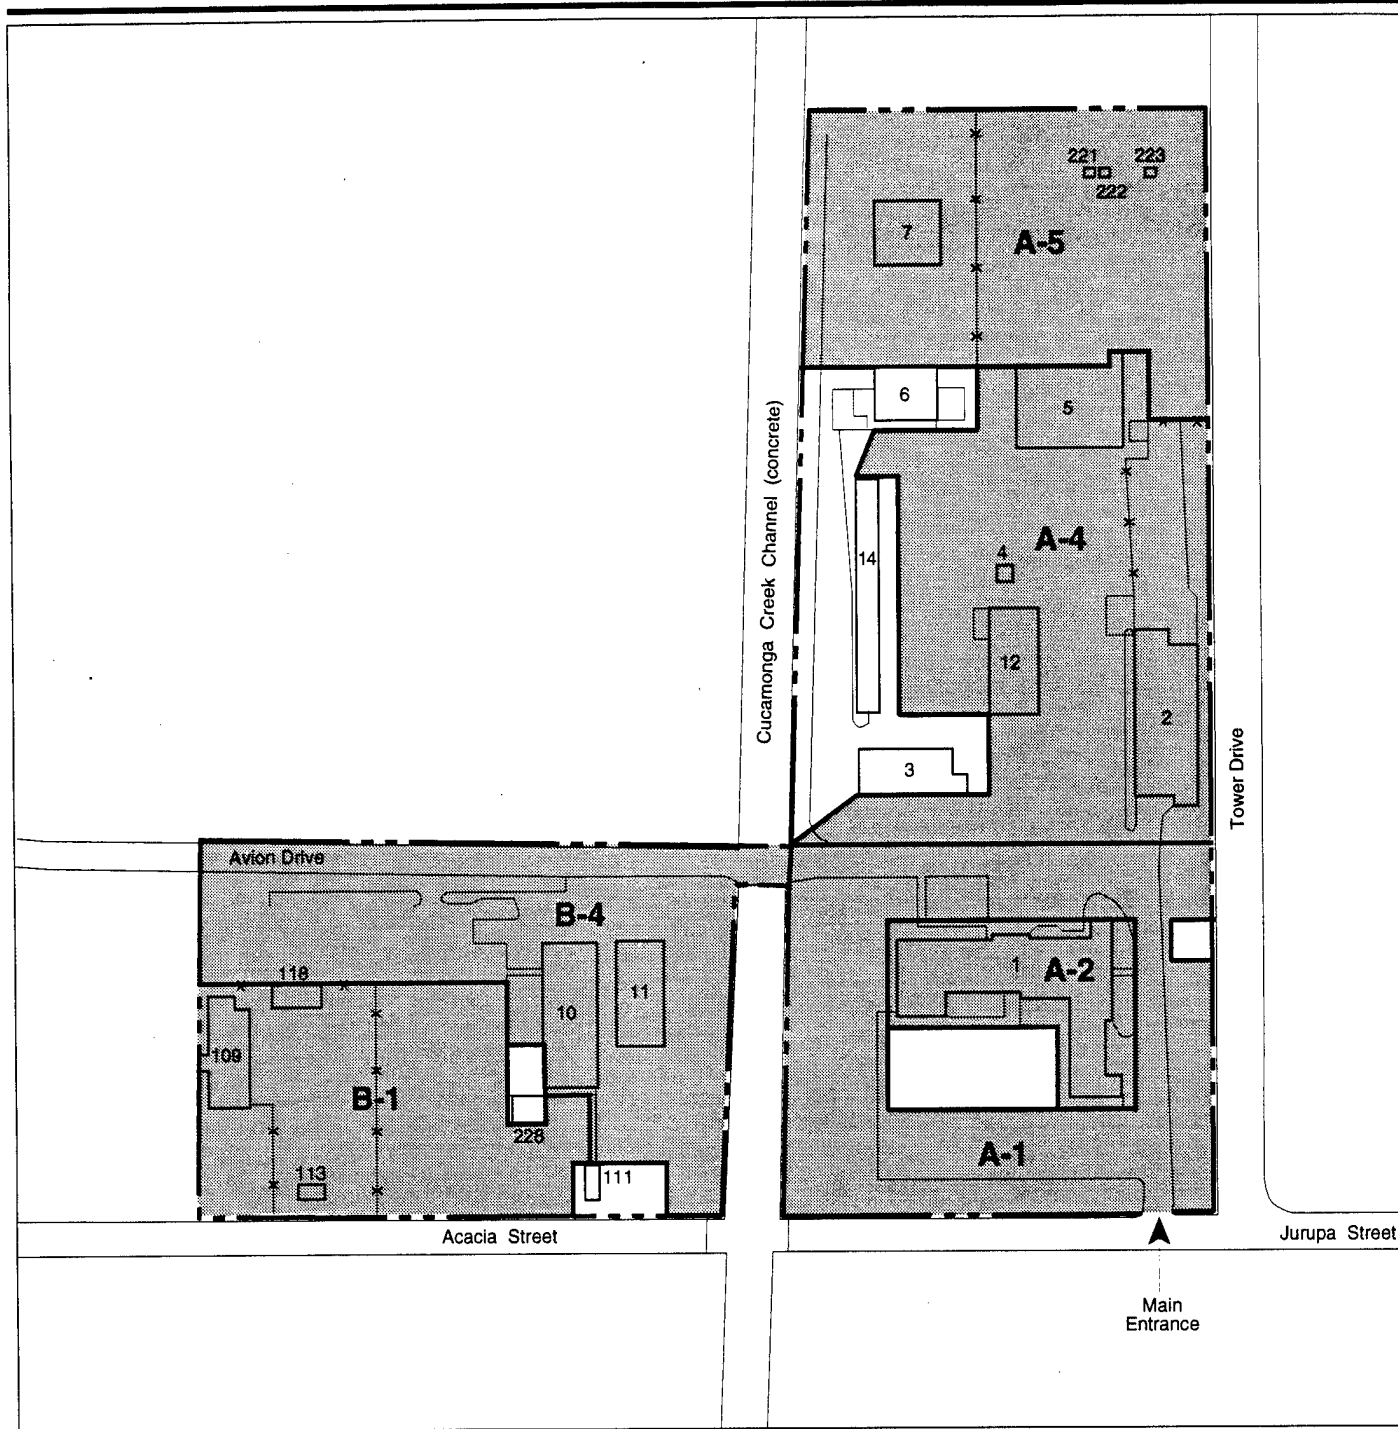
Attached is Table ES-1, which is a listing of all uncontaminated property based on information obtained through a records search, interviews, and visual site inspections at Ontario ANGS. Figure ES-1 depicts their respective locations.

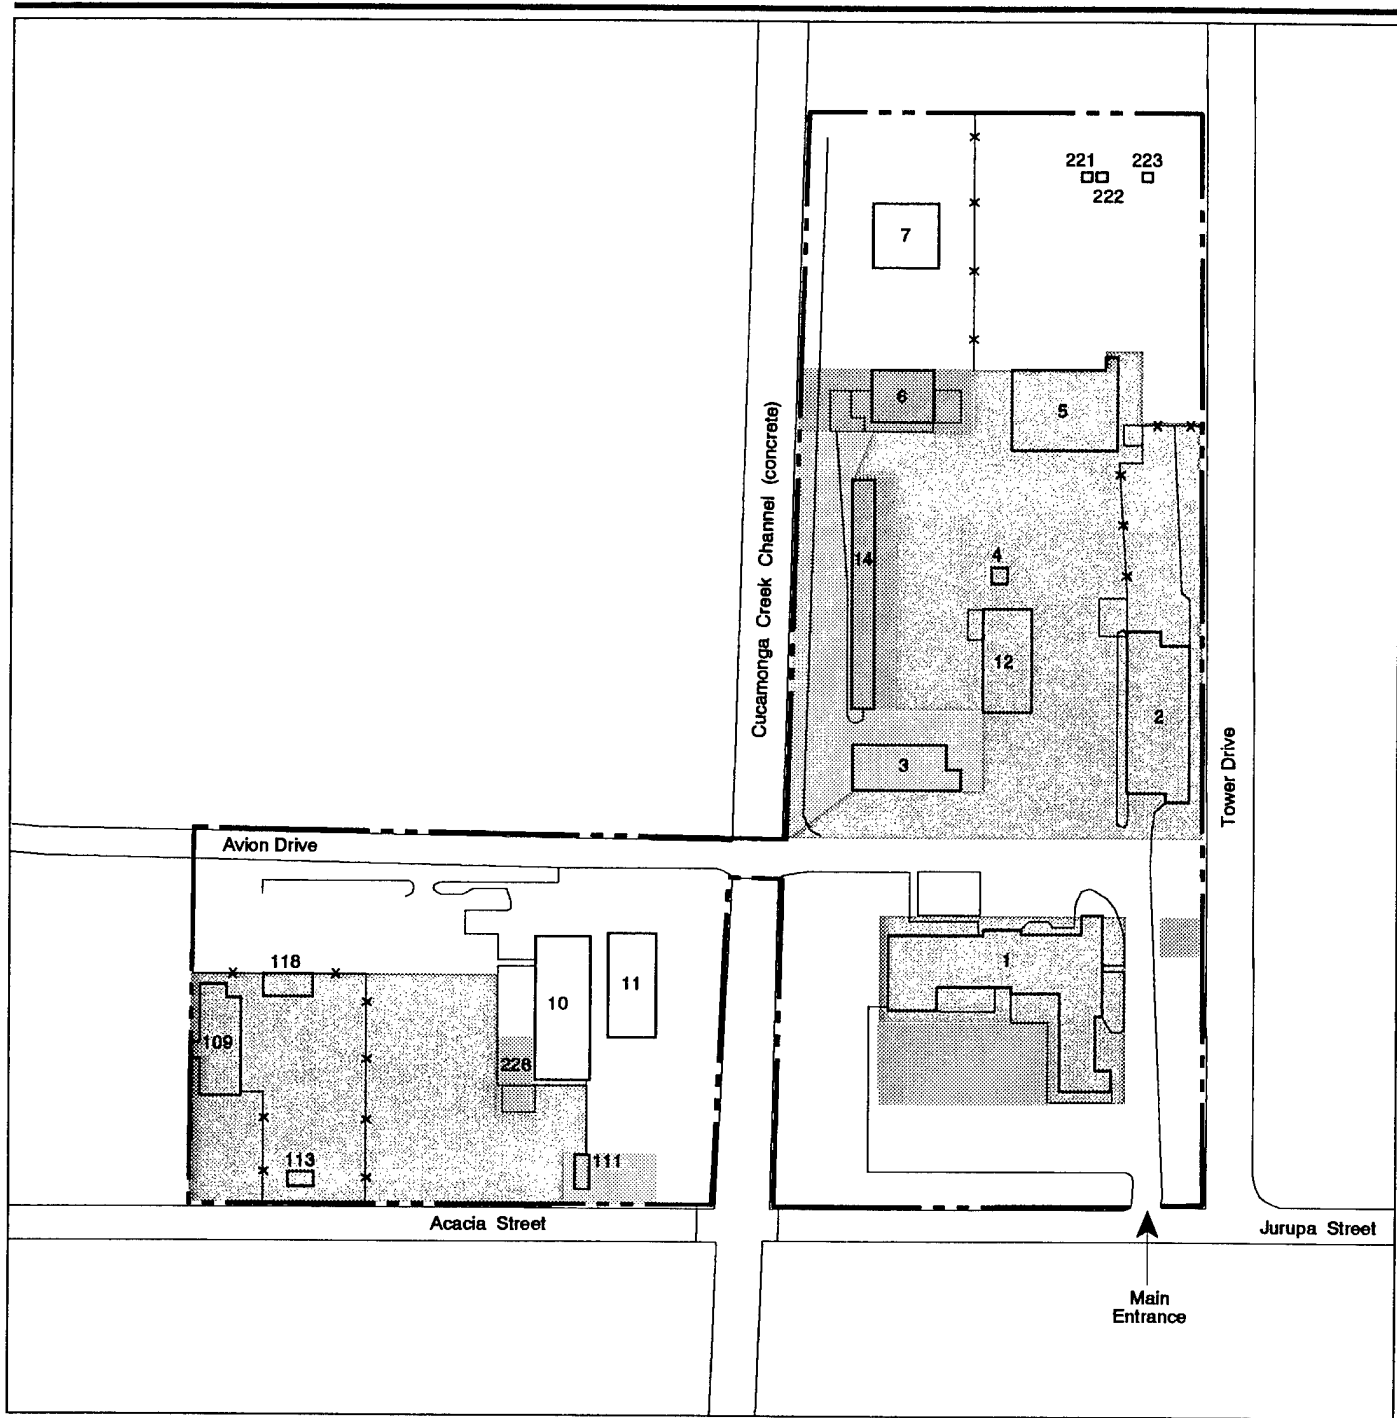
S.2.1.2 Property Categorization. As described above, property on Ontario ANGTS was classified into one of eight categories based on the findings of this EBS (Figure S-1). Category 1 properties generally occur in the vehicle parking area for Building 1, the northern portion of the station where munitions storage activities once took place, and around the administration and dining hall west of Cucamonga Creek. Category 2 properties occur throughout the central portion of the station including Buildings 1, 2, 4, 5, and 12, and most of the area west of Cucamonga Creek. Category 3 property is associated with IRP Sites SS-01 and ST-03. Portions of the storm drain system are also considered Category 3 as a result of past disposal activities. No Category 4, 5, or 6, properties were identified. Category 7 properties include Buildings 6 and 14 where subsurface soil conditions at OWSs are unknown. A grease trap (Facility 228) located adjacent to Building 10 is also considered Category 7 due to unknown subsurface soil conditions. The septic tanks and leach fields associated with

Buildings 2 and 6 may have received hazardous substances and are considered Category 7. An area located south of Building 1 may have been utilized as a burn pit in the mid-1940s and is considered Category 7. IRP Site ST-02 is considered Category P_R as a result of past releases from fuel oil USTs, but is not shown on the figure because other factors contribute to the property, which outweighs Category P_R.

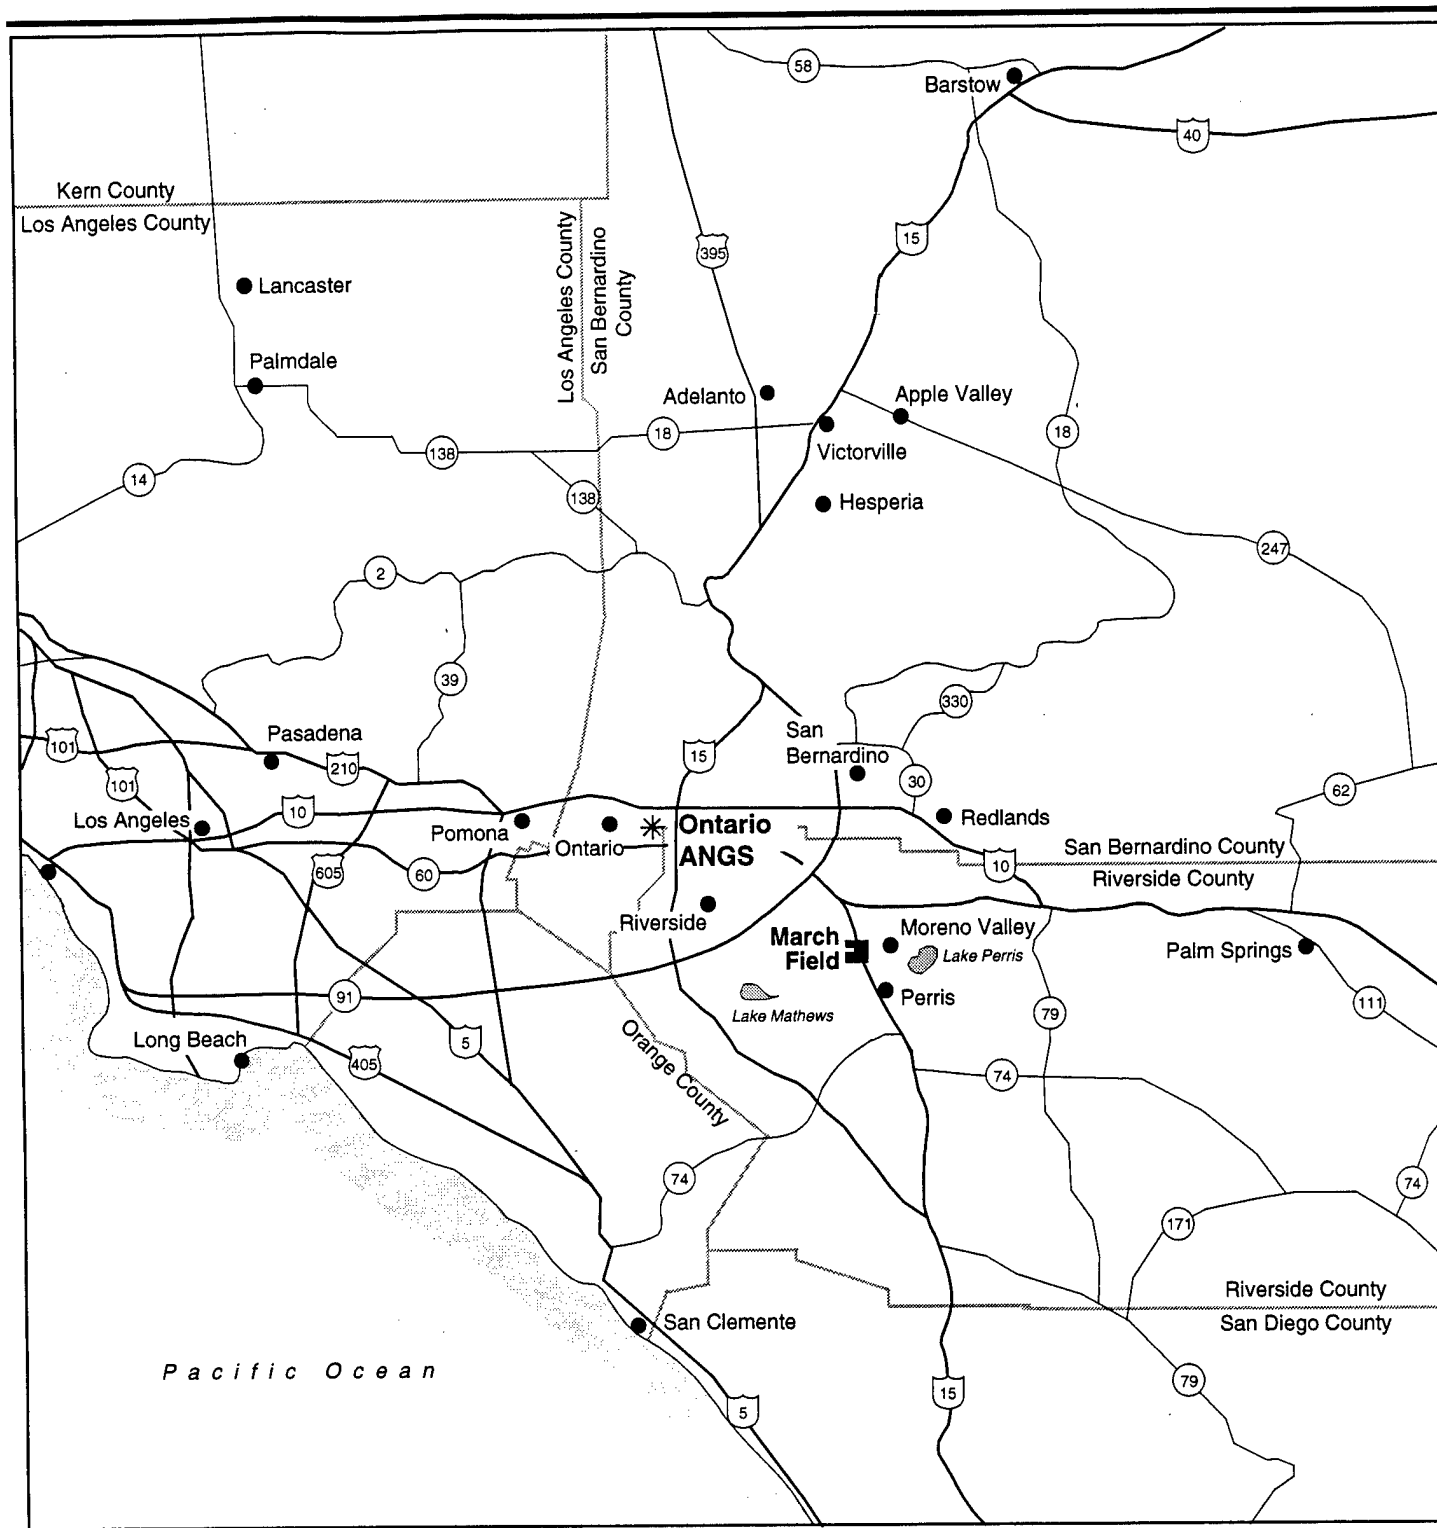
Figure 1-1

Ontario ANGTS, consisting of 8 acres of fee-owned land and 3 acres of leased property, is scheduled for closure in September 1997. The station is located in San Bernardino County, California, within the city of Ontario. It borders the southern boundary of the Ontario International Airport and is approximately 3 miles southeast of downtown Ontario and 35 miles east of Los Angeles (Figure 1-1). Figure 1-2 shows roads and major features at Ontario ANGTS.

Regional Map

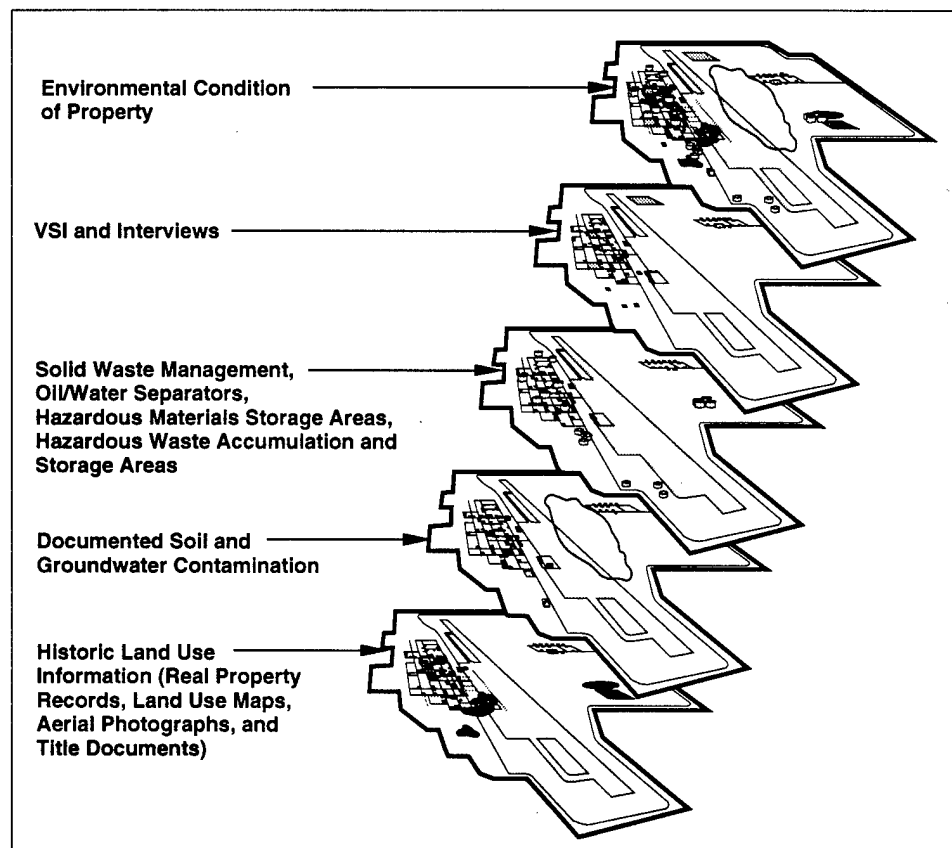
Figure 2-1 Resource Layer Approach

The result of this process is a series of information layers that, when laid over one another, provide a picture of the environmental condition of the property that was used to classify the property into defined environmental condition categories (see Section 1.1) and to identify data gaps (Figure 2-1).

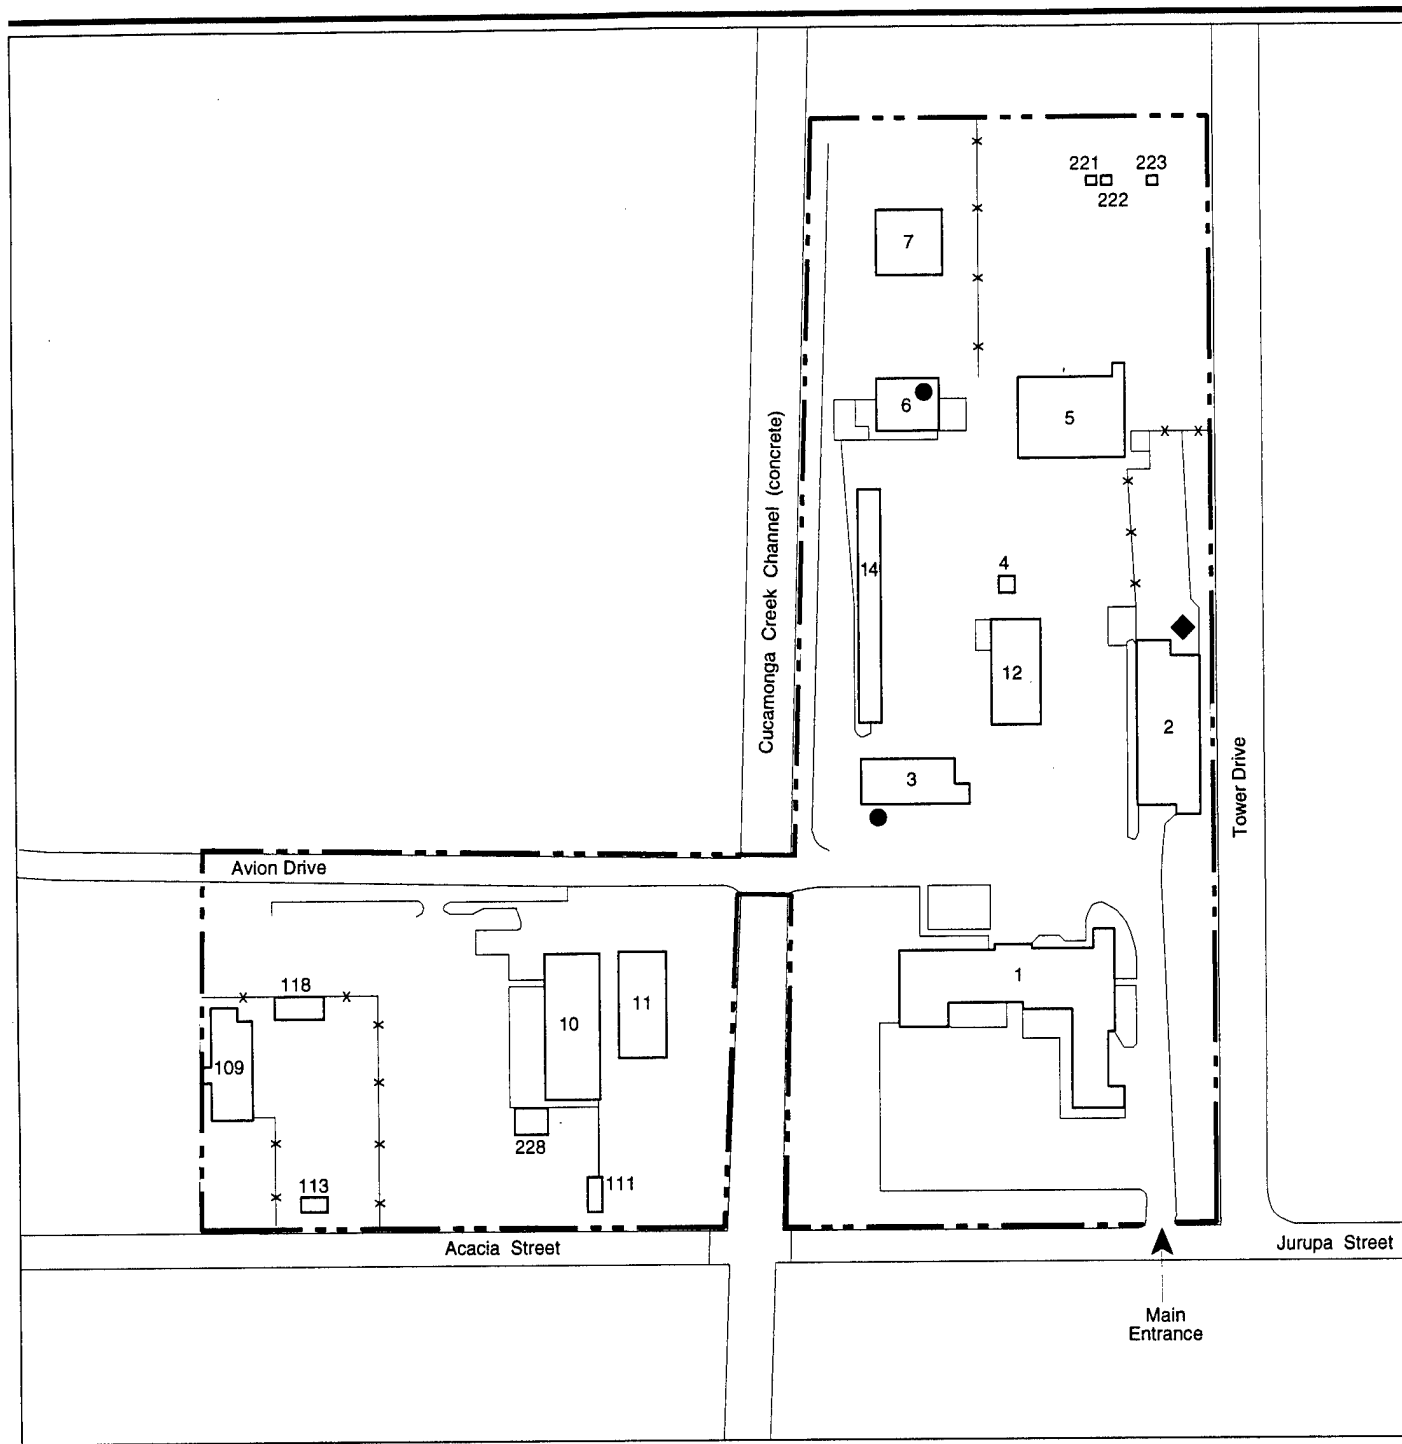
Hazardous Waste Storage Locations

3.3.1.2 Hazardous Waste and Waste Petroleum Products. Station records dating from 1993 were reviewed to identify quantities and types of hazardous wastes and petroleum wastes generated or stored in station facilities. Hazardous wastes and/or waste petroleum products were stored at Buildings 2, 3, and 6. Appendix C, Table C-2, provides an inventory of Hazardous Waste and Waste Petroleum Product Storage Areas. Hazardous waste manifests were reviewed for information on types and quantities of hazardous wastes or waste petroleum products stored by facility. The review of the hazardous waste manifests did not yield any usable information. Figure 3-6 shows the locations of facilities in which hazardous wastes or petroleum wastes were stored.

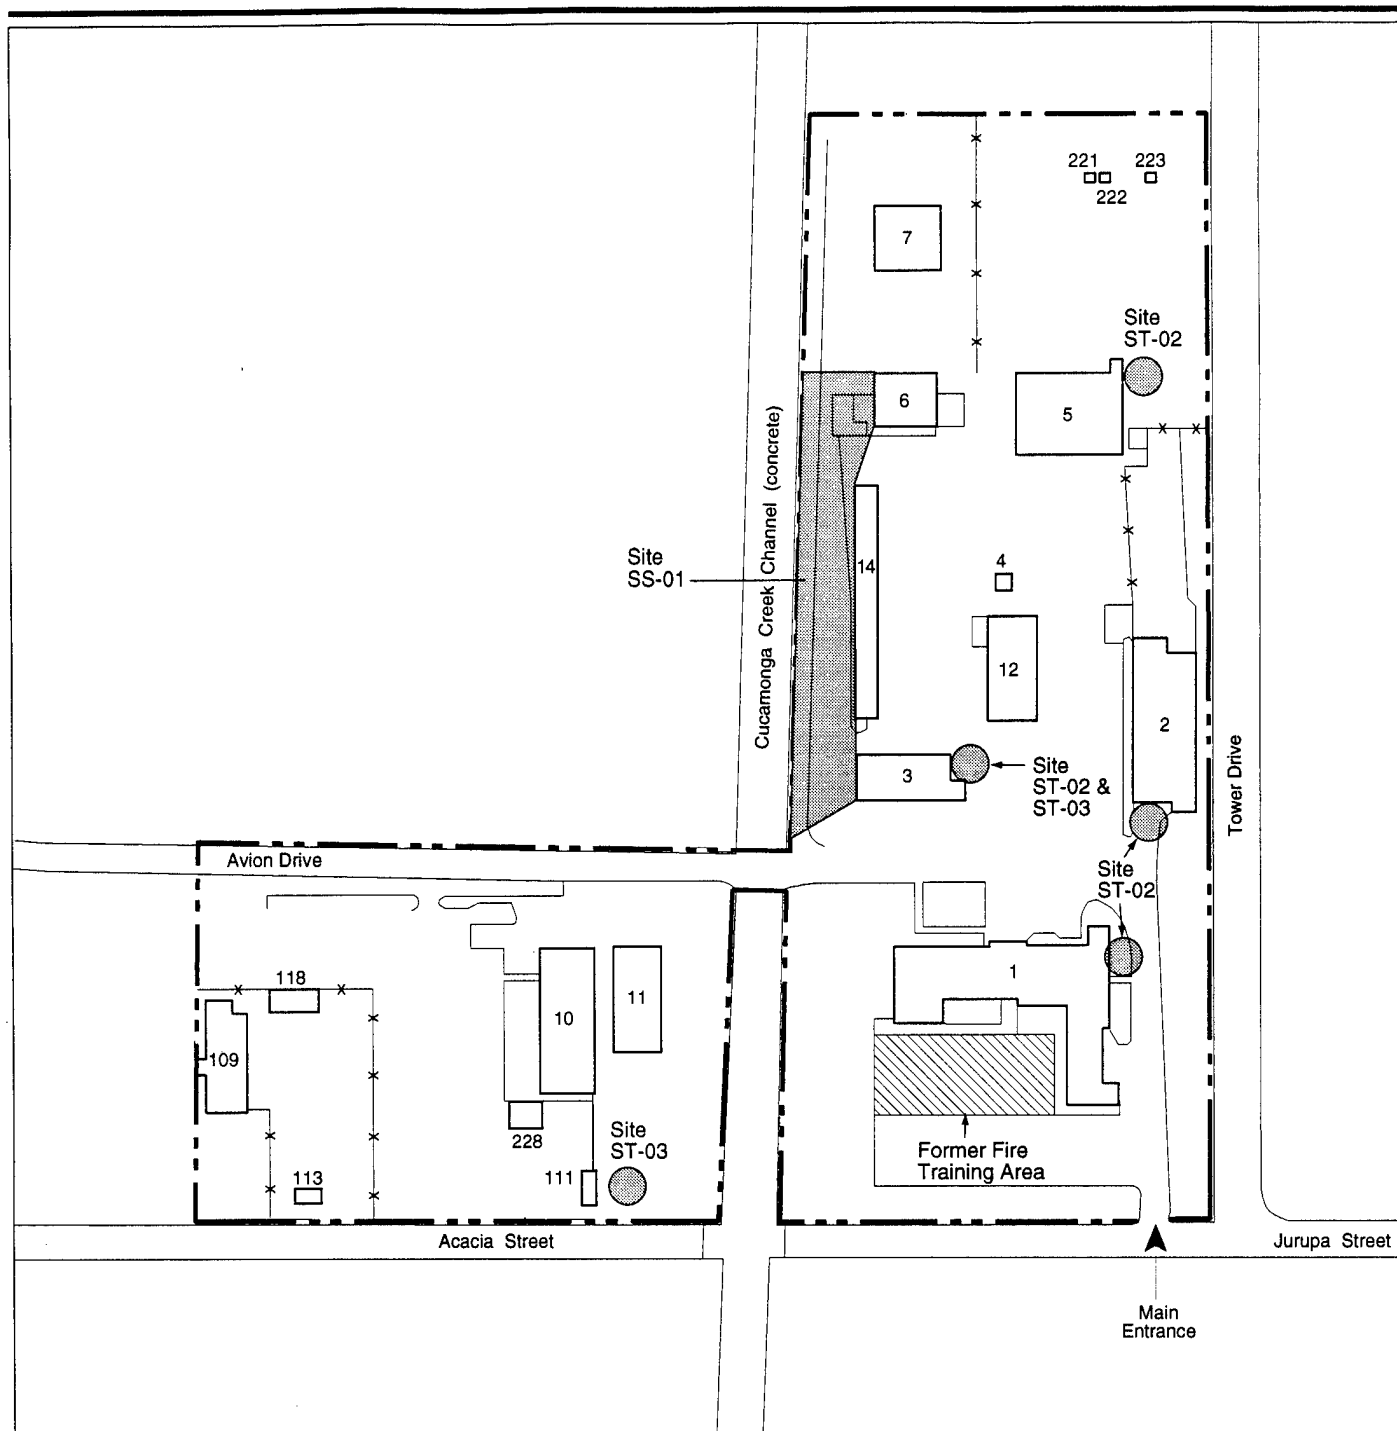
3.3.2.2 IRP History. The Air Force began the IRP process at Ontario ANGTS in 1990 with a PA. It initially identified three areas of possible contamination (Figure 3-7). Of these sites, one (IRP Site SS-01) was

A	NA	Former Fire Training Area	Further investigation recommended	In the mid-1940s, the area south of Building 1 was used as a fire training area. Specific activities conducted are unknown.	7

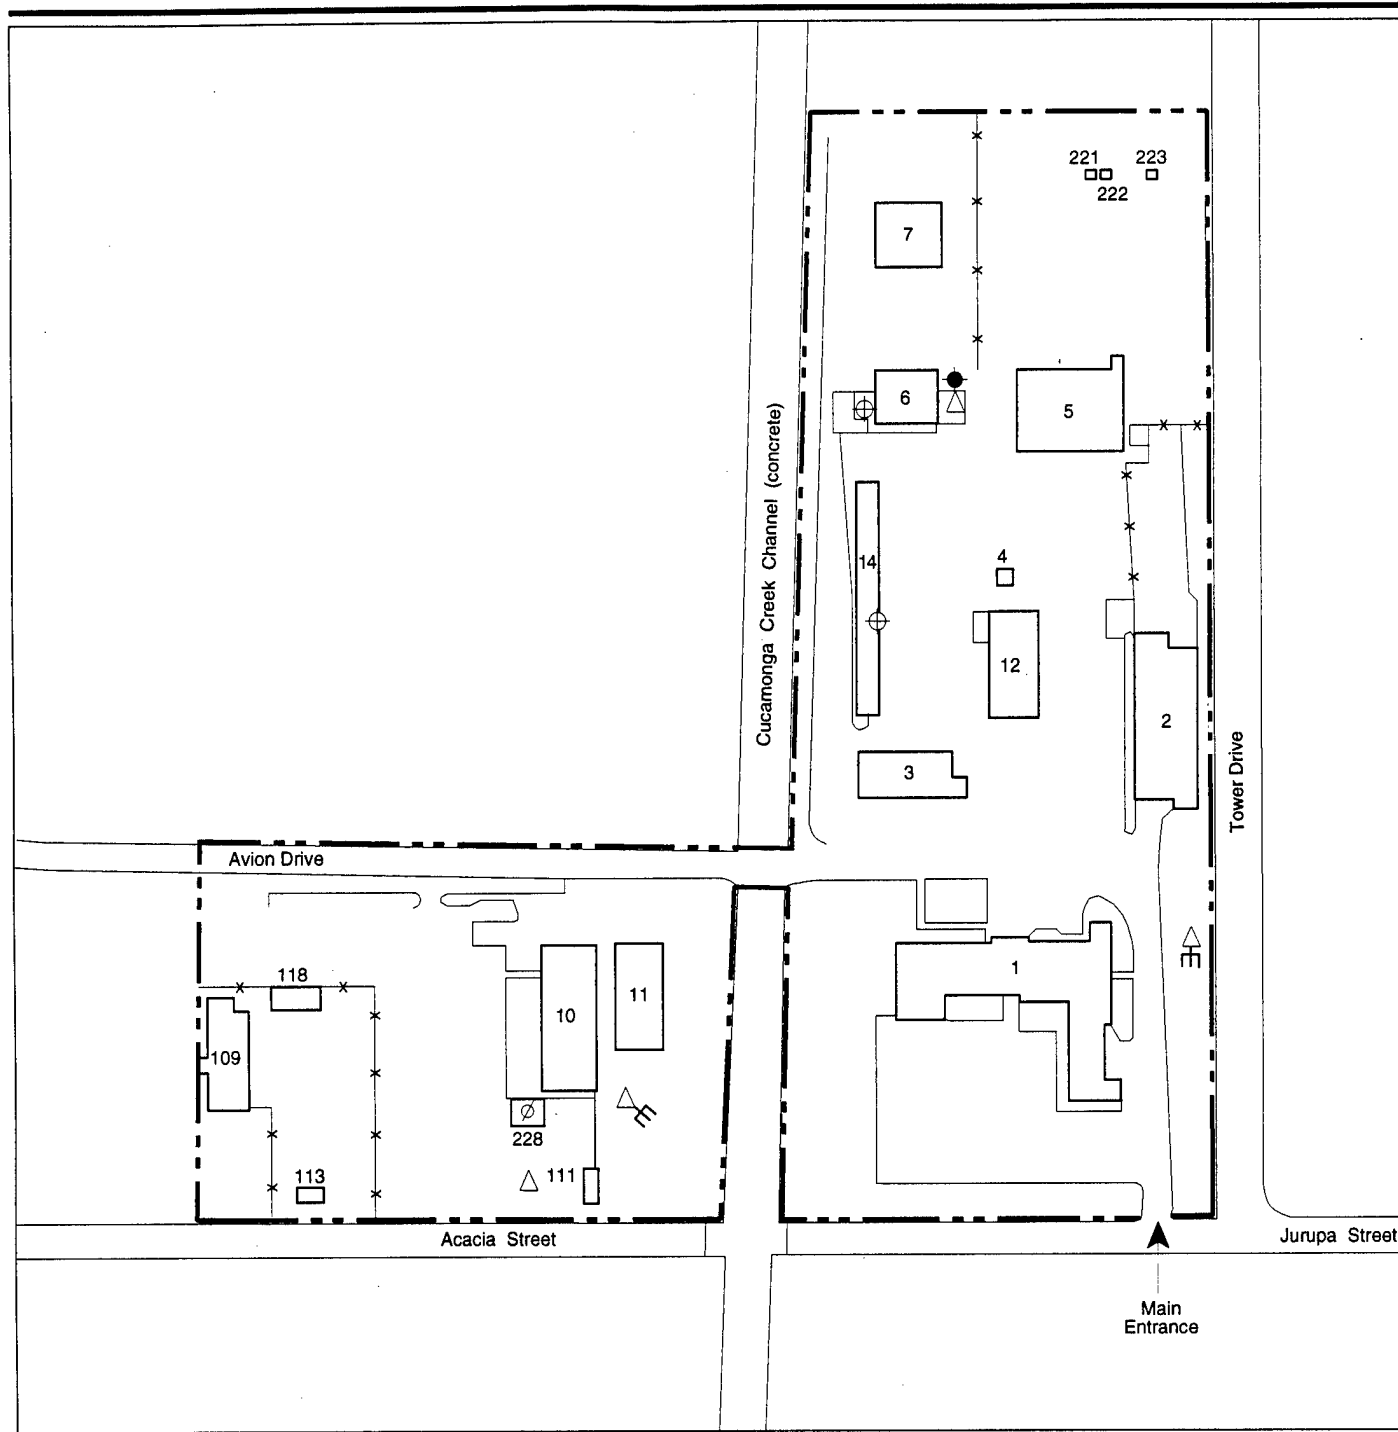
3.3.4.3 Septic Tank Systems. Four septic tank systems were located at Ontario ANGTS (Figure 3-9). All septic tanks had a capacity of 750 gallons and were abandoned in place in 1972 when the station was connected to

- OWS and grease trap locations have unknown subsurface soil conditions and may require further investigation (see Section 3.3.4.2).
- Septic tanks and leach fields associated with Buildings 2 and 6 may have received hazardous substances and require further investigation (see Section 3.3.4.3).
- Facility-specific information regarding hazardous material storage was not available.
- Facility-specific information regarding hazardous waste generation was not available.
- The area south of Building 1 that may have been utilized as a burn pit may require further investigation.

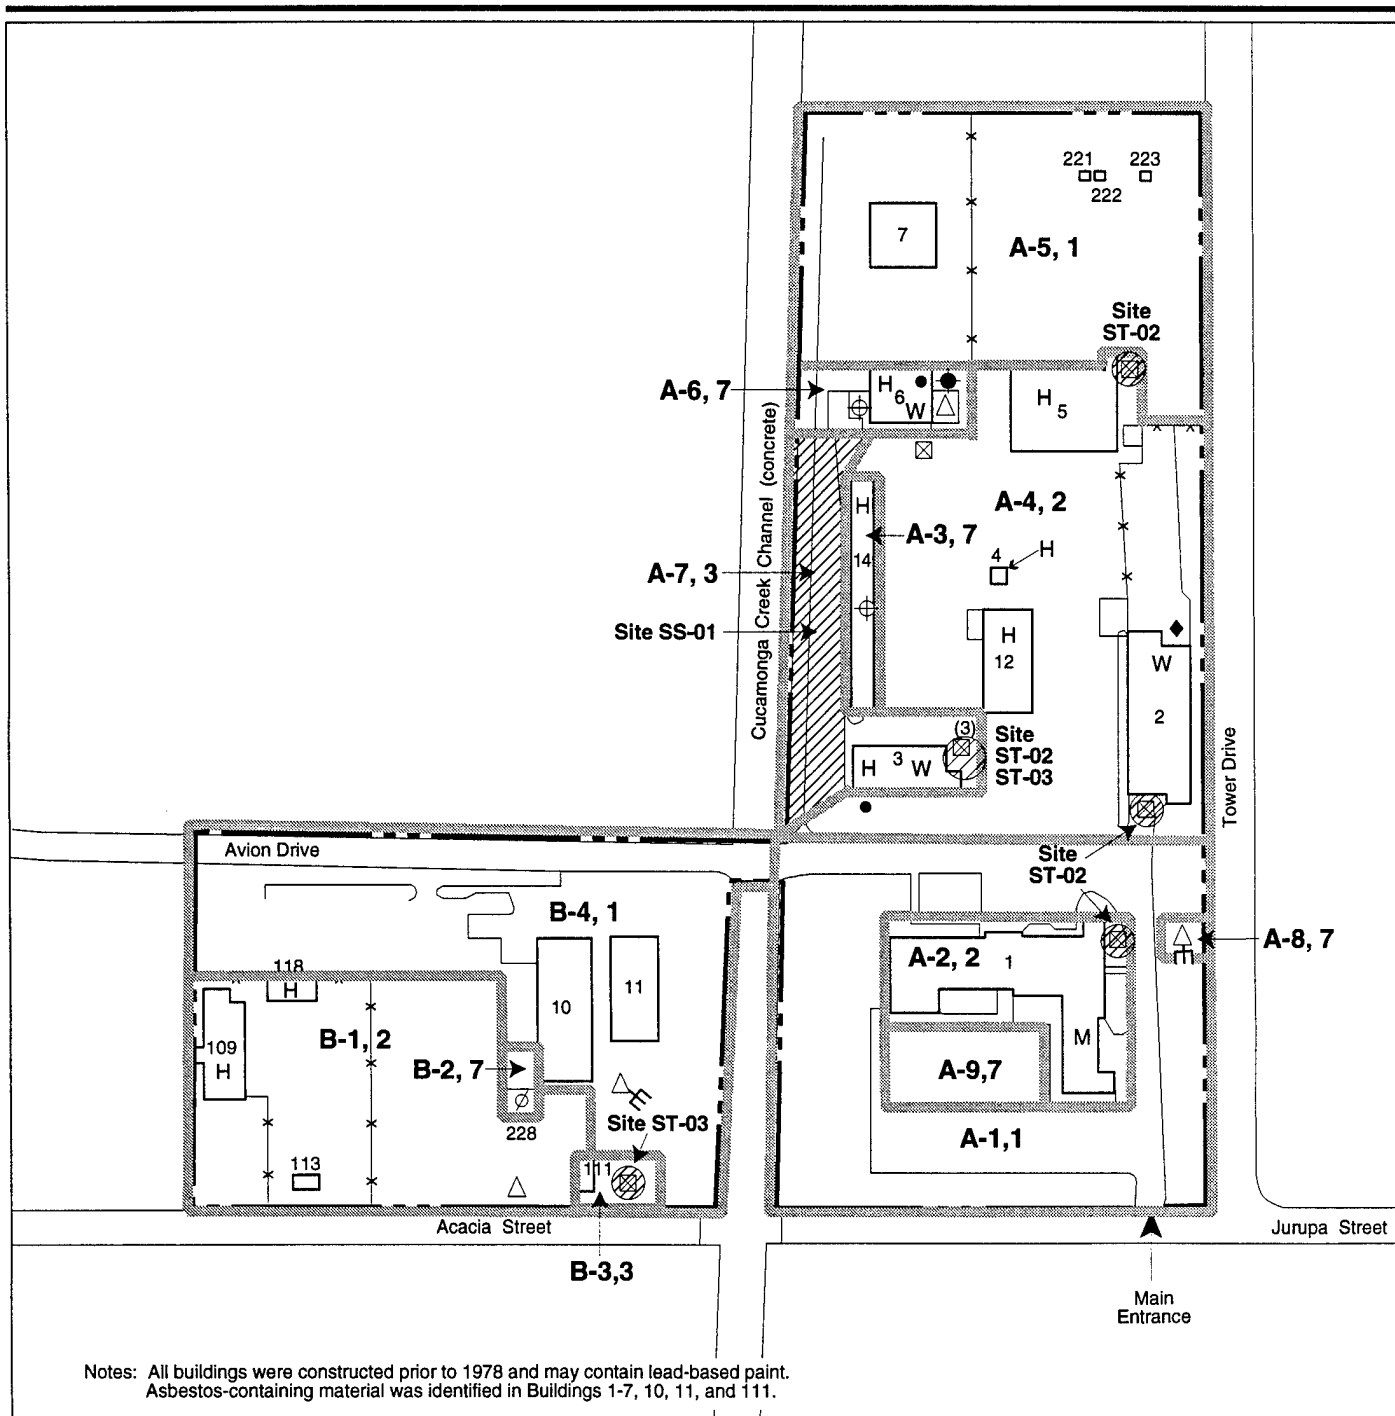
Figure 5-1

Location of Environmental Factors
